# The Tower

Squerries Estate Westerham

### INTRODUCTION

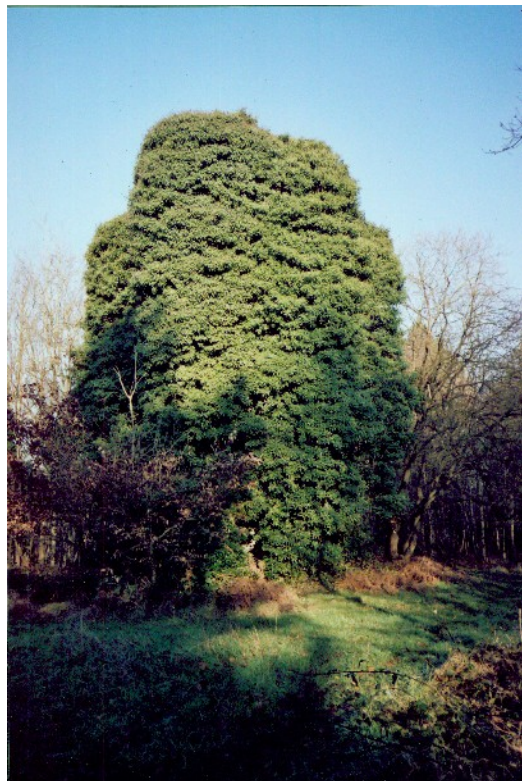
Ivy Covered Tower in 2009

The first part of this study was to visit the tower and with the permission of the estate owner Mr John Warde make a measured ground plan, this was carried out in 2009 and at the same time a series of photographs were taken of the inside features of the tower. It was not possible to see any of the exterior of the tower as it is completely covered in a dense growth of ivy.

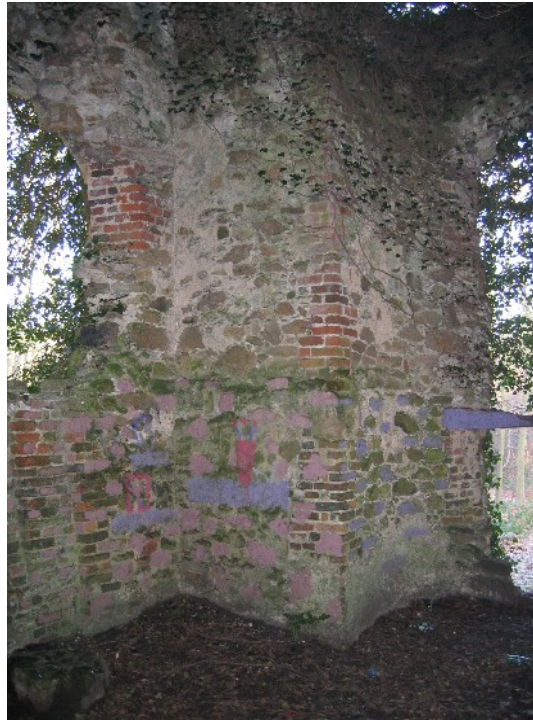
Brick reveals.

In order to fully appreciate exactly what the tower consisted of it was necessary to draw up a set of scale plans showing all those features that could be seen both in the building itself and also what could be deduced from any images. Due to the fragile state of the tower it was not possible to make any measurements above ground level so everything above that level had to be deduced from counting brick courses on photographs, fortunately all the reveals and fireplace are brick built which made this task fairly easy.

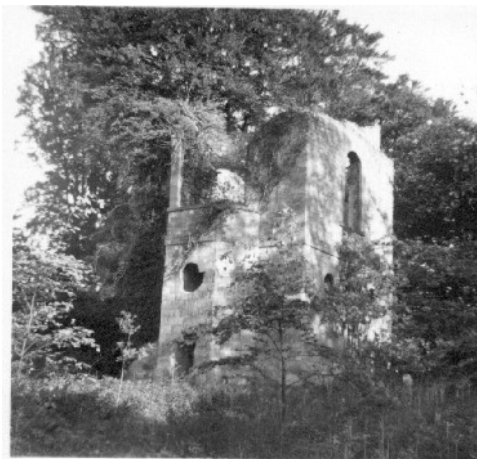
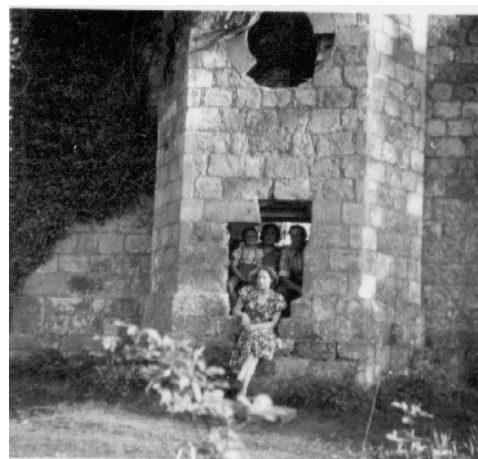
North front of the tower in 1953. Peter Finch family album.

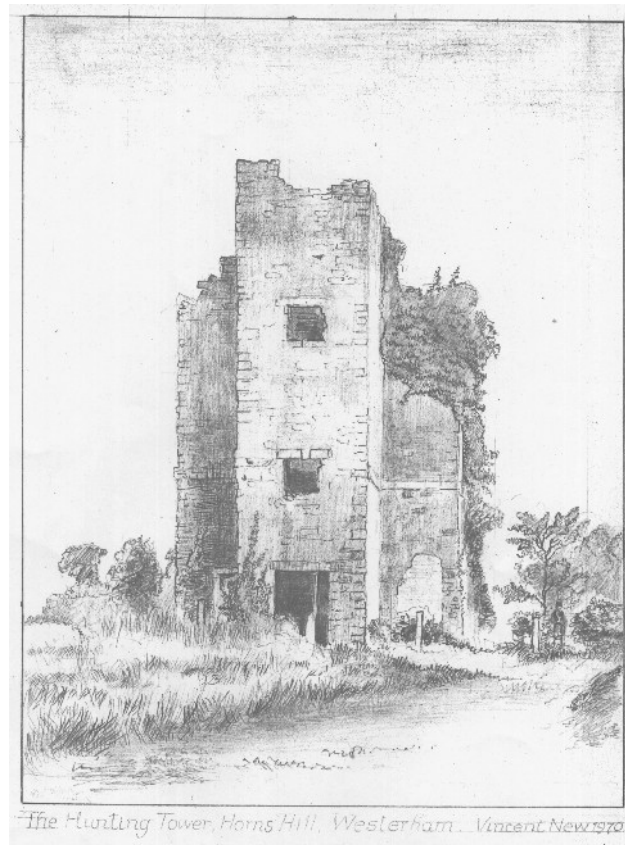
South side of the tower by Mr V New 1970.

A collection was made of images of the tower, as mentioned above, the tower has always attracted photographers and artists. Photographs varied from family snaps to professionally taken pictures to be used as postcards. Mr V New, a local artist, made a very fine set of drawings in 1970. These are accurately to scale and show great detail. Mrs Annie Anscombe made a painting of the tower which though simple, still shows useful information.

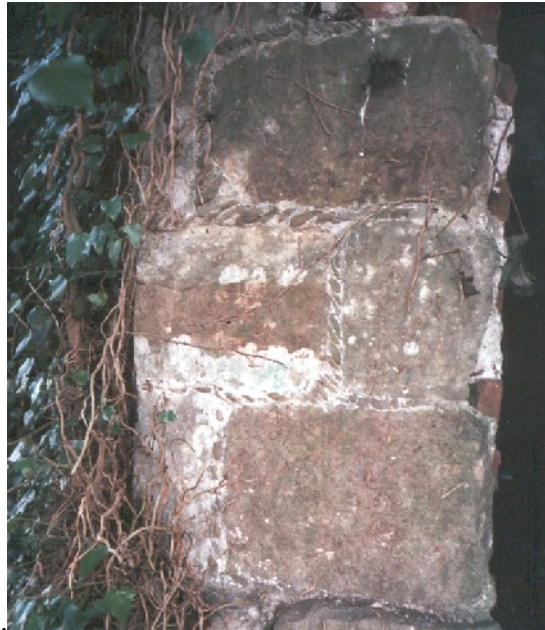
Galleted blocks on the front wall.

by contrast is laid in carefully coursed rectangular blocks of a whitish stone. These are approximately ten inches high and twelve inches long by six inches thick and are most probably from the Reigate underground quarries which are in the 'Upper Greensand' which outcrops between Brockham in the west to Godstone in the east but centred on Reigate. The Reigate quarries were worked from pre Norman times and the stone was used in several high status buildings such as the Tower of London and Hampton Court. All the mortar between the stones is galleted.

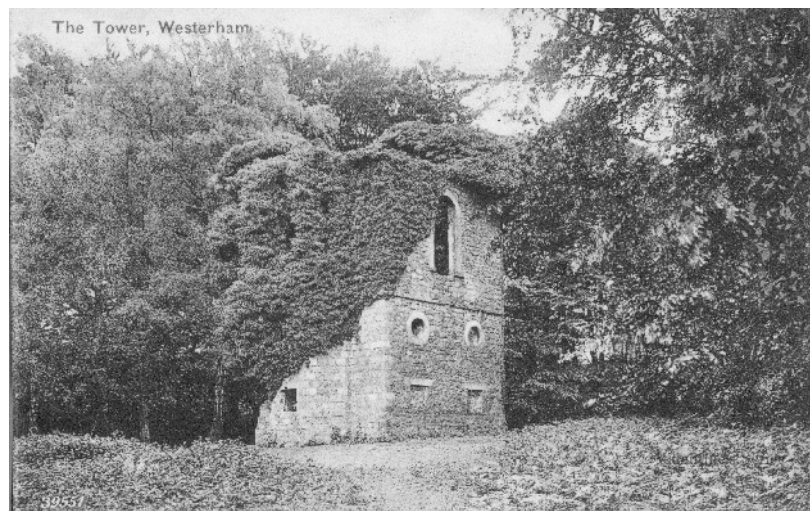
Post card c 1910 showing squared blocks and rubble masonry.

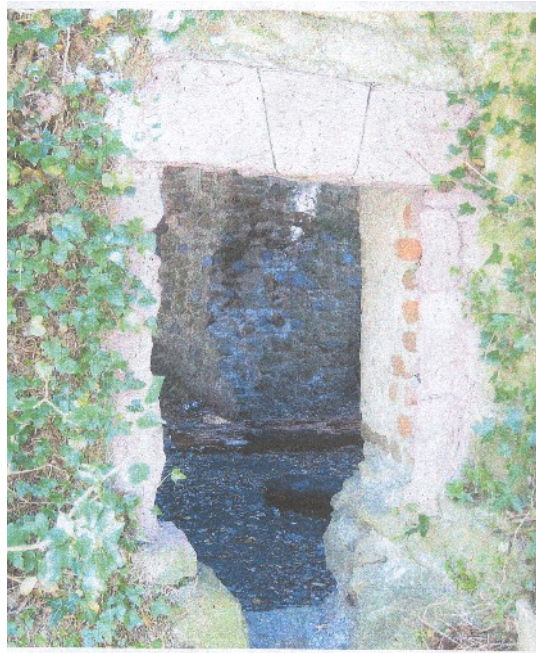
Square window with keystone. (Damaged sill)

There is a plinth in two stages below the ground floor windows and a stringcourse at the level of the second floor. The small square windows on the ground floor and the doorways all have keystones.

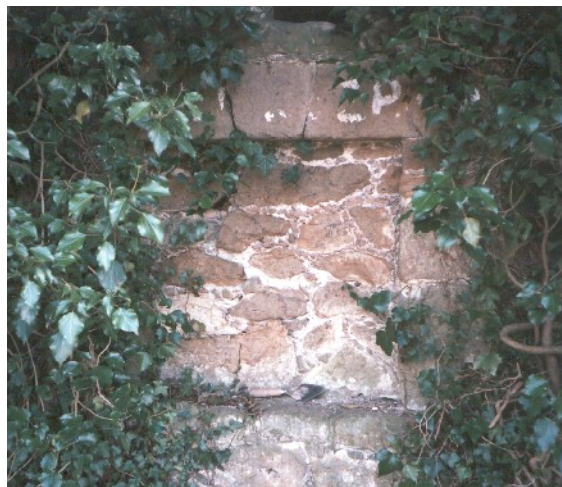
Dummy Window.

There are two dummy windows outside on the west ground floor these are where the fireplace is on the inside.

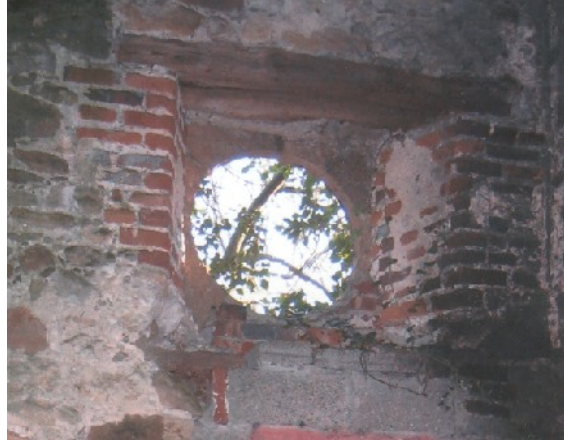
Round window inside with brick reveals.

The round windows on the first floor are square edged and have no rebates for glazing.

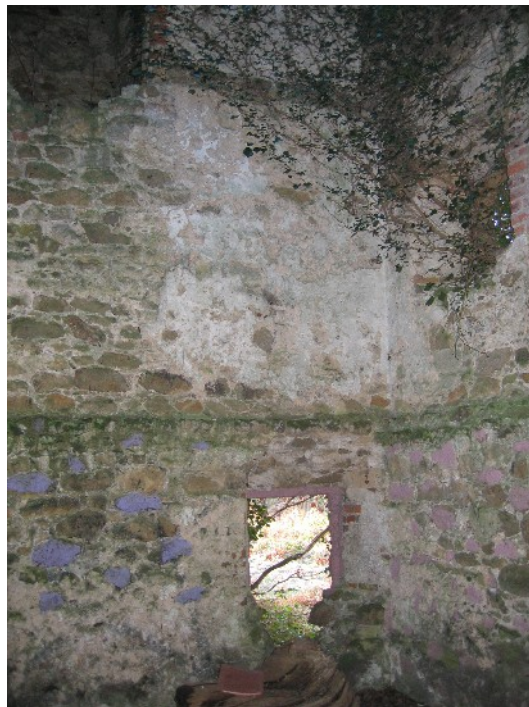
Ledge for Serlio floor on first and second levels.

Probably the most unusual feature of the tower is the fact that there are no slots in the walls to take the ends of bresumers to carry floor joists, instead at the first, second and roof level there is a three inch wide ledge that goes all round the inside of the building to take a Serlio type floor or roof.

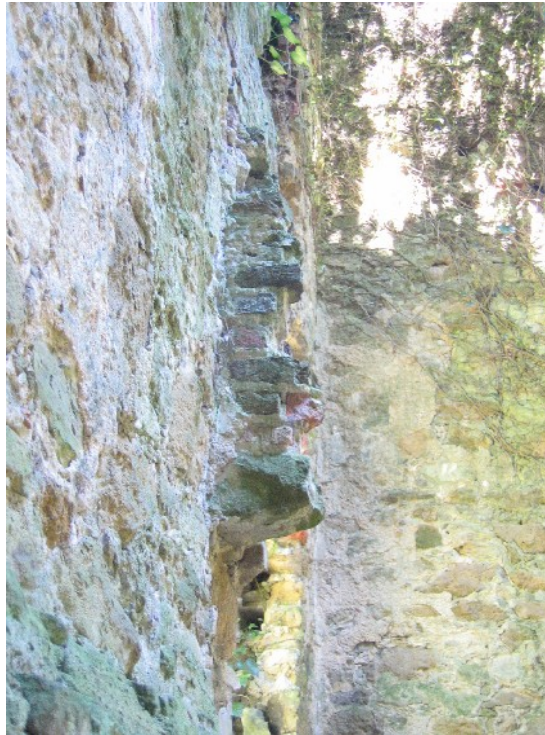
Remains of the hood.

The only fireplace is on the west wall of the ground floor and had a brick hood that was built out from the wall and which extended up into the first floor.

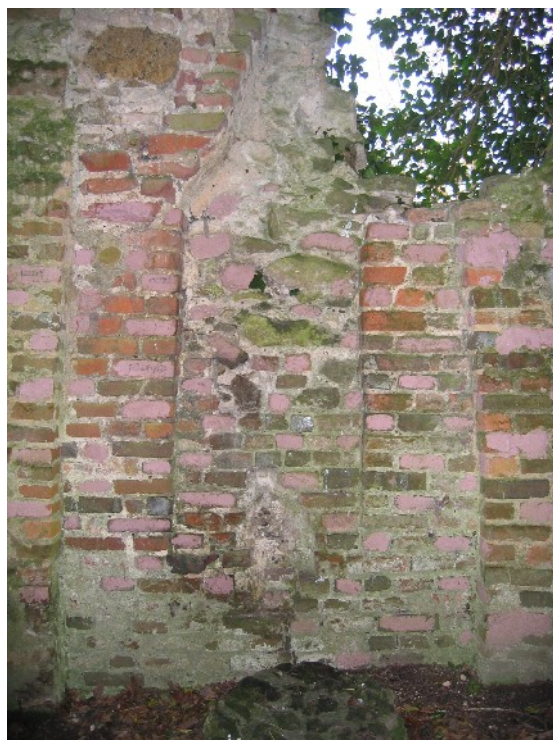
Remains of the fireplace

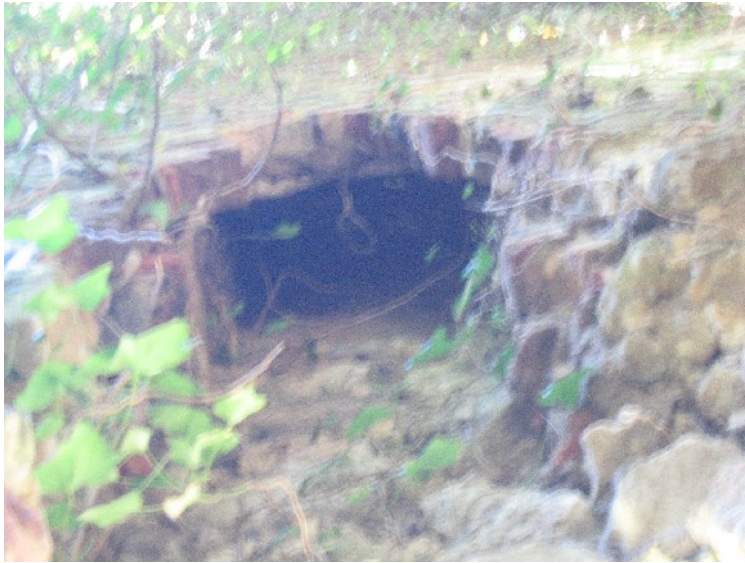
The chimney built into the thickness of the wall.

The chimney was built into the thickness of the wall and curved round one of the circular windows on the first floor.

It is likely that the chimney exited through one of the battlements.

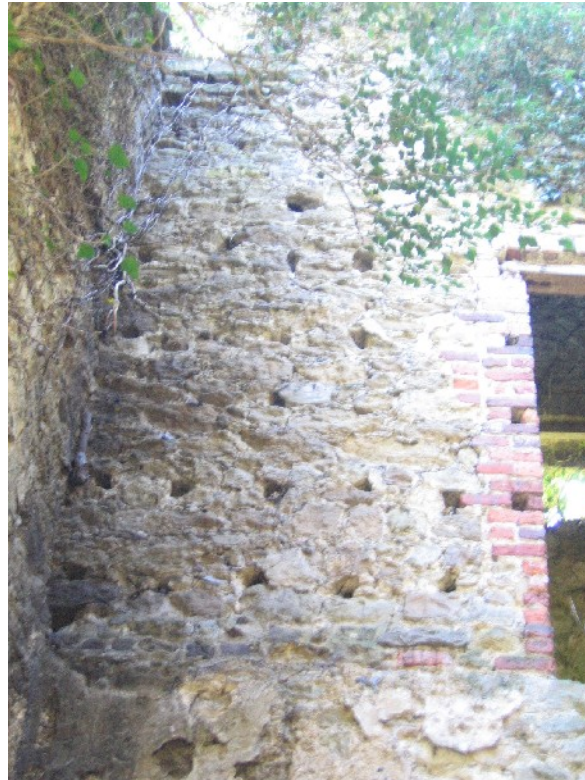
Holes for blocks to attach panelling.

The inside walls of the ground floor and the first floor were both plastered and fairly large areas of this plaster still remain in situ. The second floor by contrast was panelled. Although no panelling remains, the holes for the fixing blocks that were used to attach the panelling to the wall can still be clearly seen. These holes are about three inches square and probably of a similar depth. They are on a regular grid of about one foot six inch centres. By the 18<sup>th</sup> century panelling tended to be of pine, painted and with fairly refined mouldings.

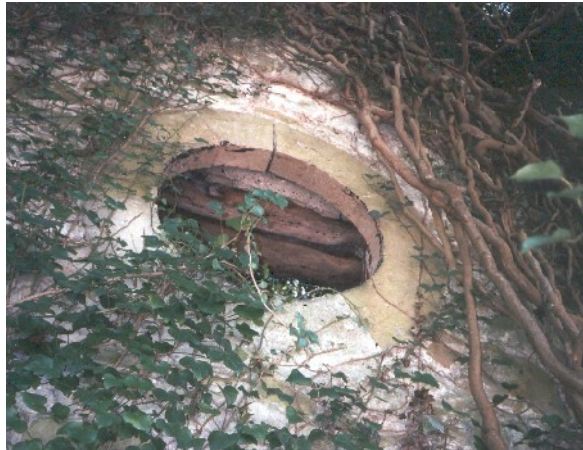
Round window with rough timber lintels

All the first floor windows are round and have an opening of approximately thirty inches diameter. The frames are of stone and are made up of six unequal segments about four inches thick. Again the masonry in the thickness of the walls is carried on rough timbers.

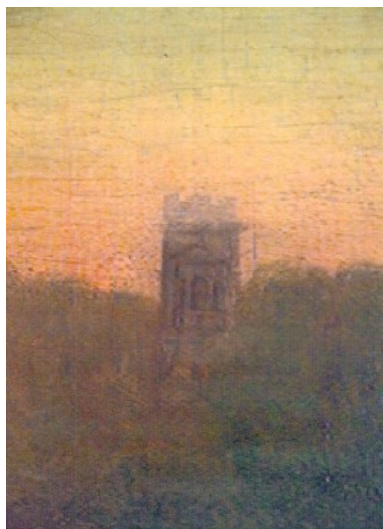
Enlargement of Wootton's painting of 1735.

The windows of the second floor are altogether much more splendid than those on the lower floors. In the west wall the window still retains its semicircular head and stone frame, it is set in a deep recess that continues down to the floor, It almost certainly originally had a double hung sash window. The window in the east wall is identical but much less complete. The window in the north wall is a bay window but is much destroyed. It is likely that originally it had a round head with pediment over it and was also a double hung sash. Wootton's painting of 1735 in which the tower appears very tiny in the distance shows just such an arrangement.

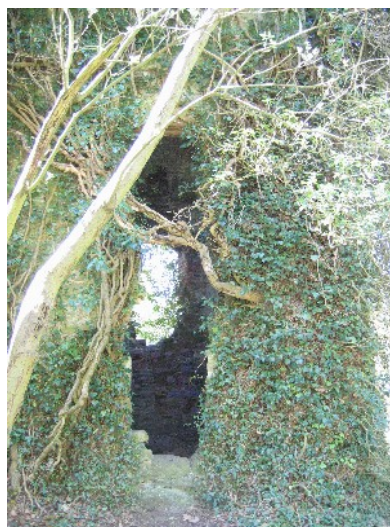
Two windows on the east side running into one.

Although the bulk of the masonry of the tower is in reasonable order the ivy that now covers the whole building will eventually work its way into the mortar and will then start to prise out masonry blocks. Several of the windows have lost their surrounds and the ragged holes are gradually getting bigger until in some cases the first floor windows have already run into the ground floor windows.
